MRO ASIA-PACIFIC 2020 SUPPLEMENT

The Inside Job

Dirty, scuffed cabins can affect an airline's reputation, so ensuring aircraft interiors and their associated systems are well maintained is vital

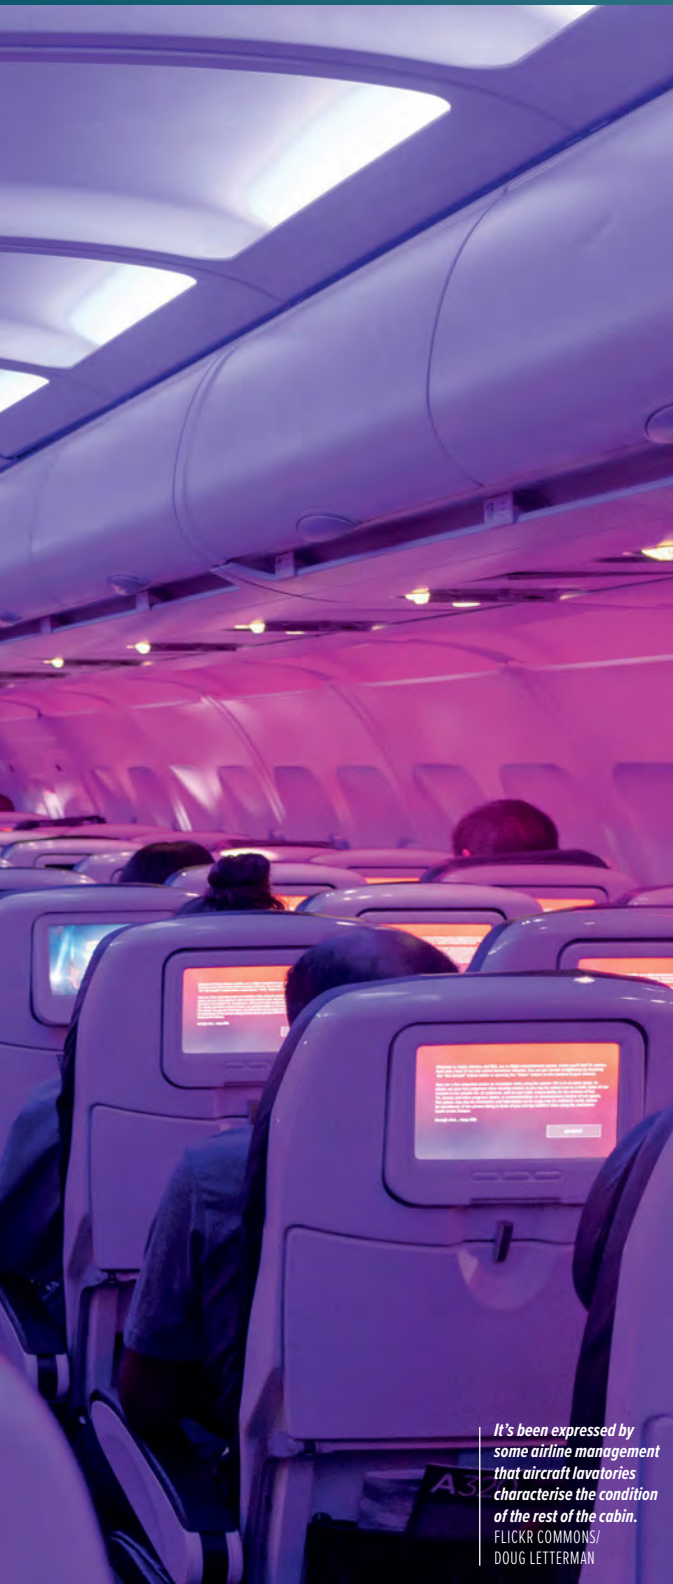
It's been expressed by some airline management that aircraft lavatories characterise the condition of the rest of the cabin.
FLICKR COMMONS/
DOUG LETTERMAN

"In addition, some airlines underline that lavatories define the condition of the whole cabin, therefore the high standard during lavatory upgrade programmes is always the key for the MAC team. We put [in] great effort to support our customers with solutions to modify [and] refurbish lavatories, as we have extensive experience and knowhow on this. [In the] meantime, the various monument wear and tear issues are resolved by bringing on board innovative ideas and solutions, like replacing outdated class dividers with glass versions," he added.

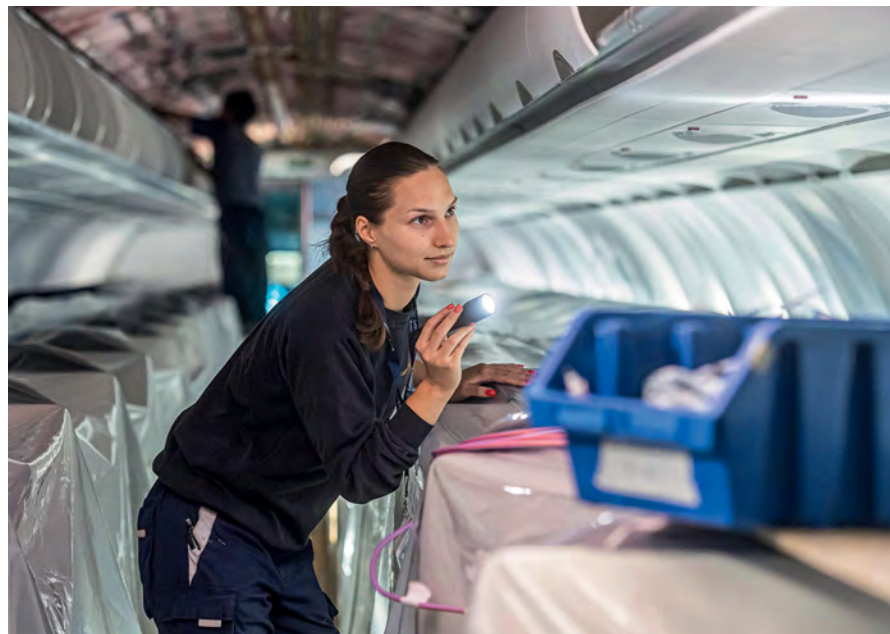
Above right • Wet areas of the aircraft cabin generally exhibit severe corrosion on aluminium structures.
LUFTHANSA TECHNIK

partitions, galleys, seats and lavatories are affected by various kinds of corrosion. This is especially true in wet areas in the entrance of an aircraft, and all galleys tend to show severe corrosion on aluminium structures still widely used on commercial aircraft," she stated.

"The main reason for corrosion is generally moisture ingress between floor covering and underlying structures. Spilled juices, acid rain in combination with temperature changes and friction in between the connections causes such corrosion," Schulz continued.

"Also the common time-saving practice during smaller maintenance events – to avoid monument removal for exchange and renewal of non-textile floor [NTF] covering changes – floor covering are cut around the monuments or inside lavatories resulting in cuts to the aluminium surfaces – [and these] are the major root cause for [severe corrosion to] fittings and intercostal beams and fittings connecting the monuments with the floor structures. Water and spilled liquids pass through cuts and poorly sealed splices, while capillary force spreads the liquids under and in between the cavities of the attachments," she added. >>

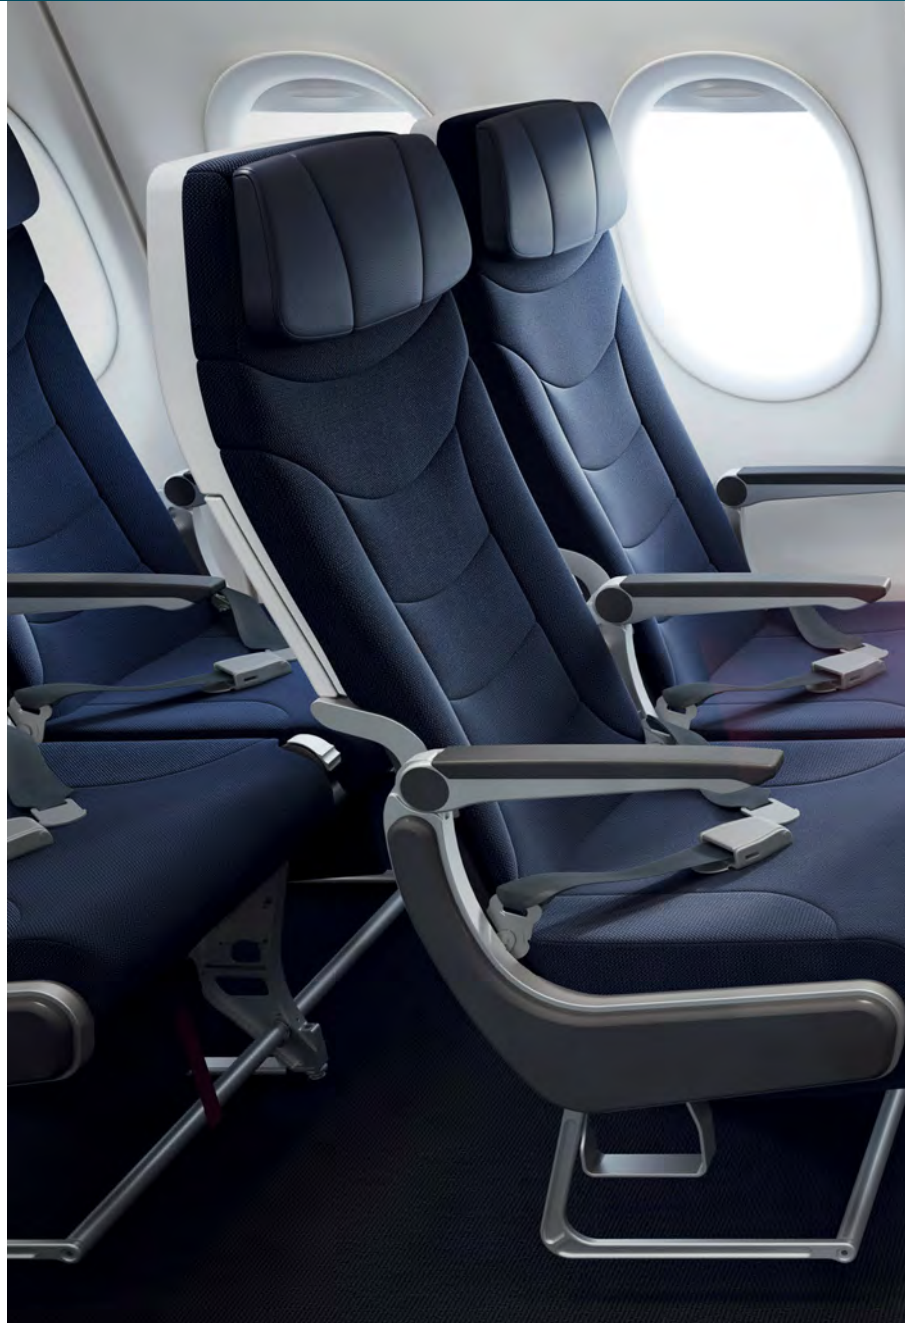
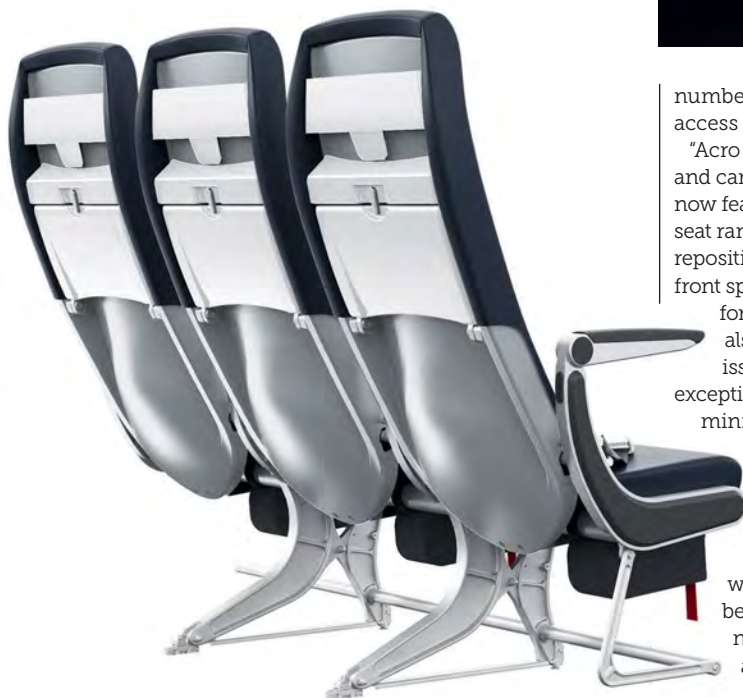
A common problem with economy seating in the past has resulted when the in-arm recline button fails. Often a complicated fix, Acro Aircraft Seating have developed a solution where the issue can now be fixed within minutes
ACRO AIRCRAFT SEATING

"One of the most common points of seating failure particularly in economy class, lies with the in-arm recline button. When the mechanism fails, passengers tend to complain long and loud, but there is no quick fix because the main drawback of the traditional in-arm recline button is its long and complicated cable run which inevitably requires the removal of a

number of components in order to access the cabling for repair.

"Acro took a fresh look at the problem and came up with a solution which now features across all our reclining seat ranges," Cairns reported. "By repositioning the recline lever to the front spar we made the recline easier for passengers to access, while also minimising maintenance issues. The seats now have an exceptionally short cable run with minimum bend so that the recline mechanism and associated cabling can be accessed easily under the composite foam seat pan cushion and can therefore be fixed 'on-wing' within minutes. As an added benefit, because armrests are no longer required to support a recline mechanism and

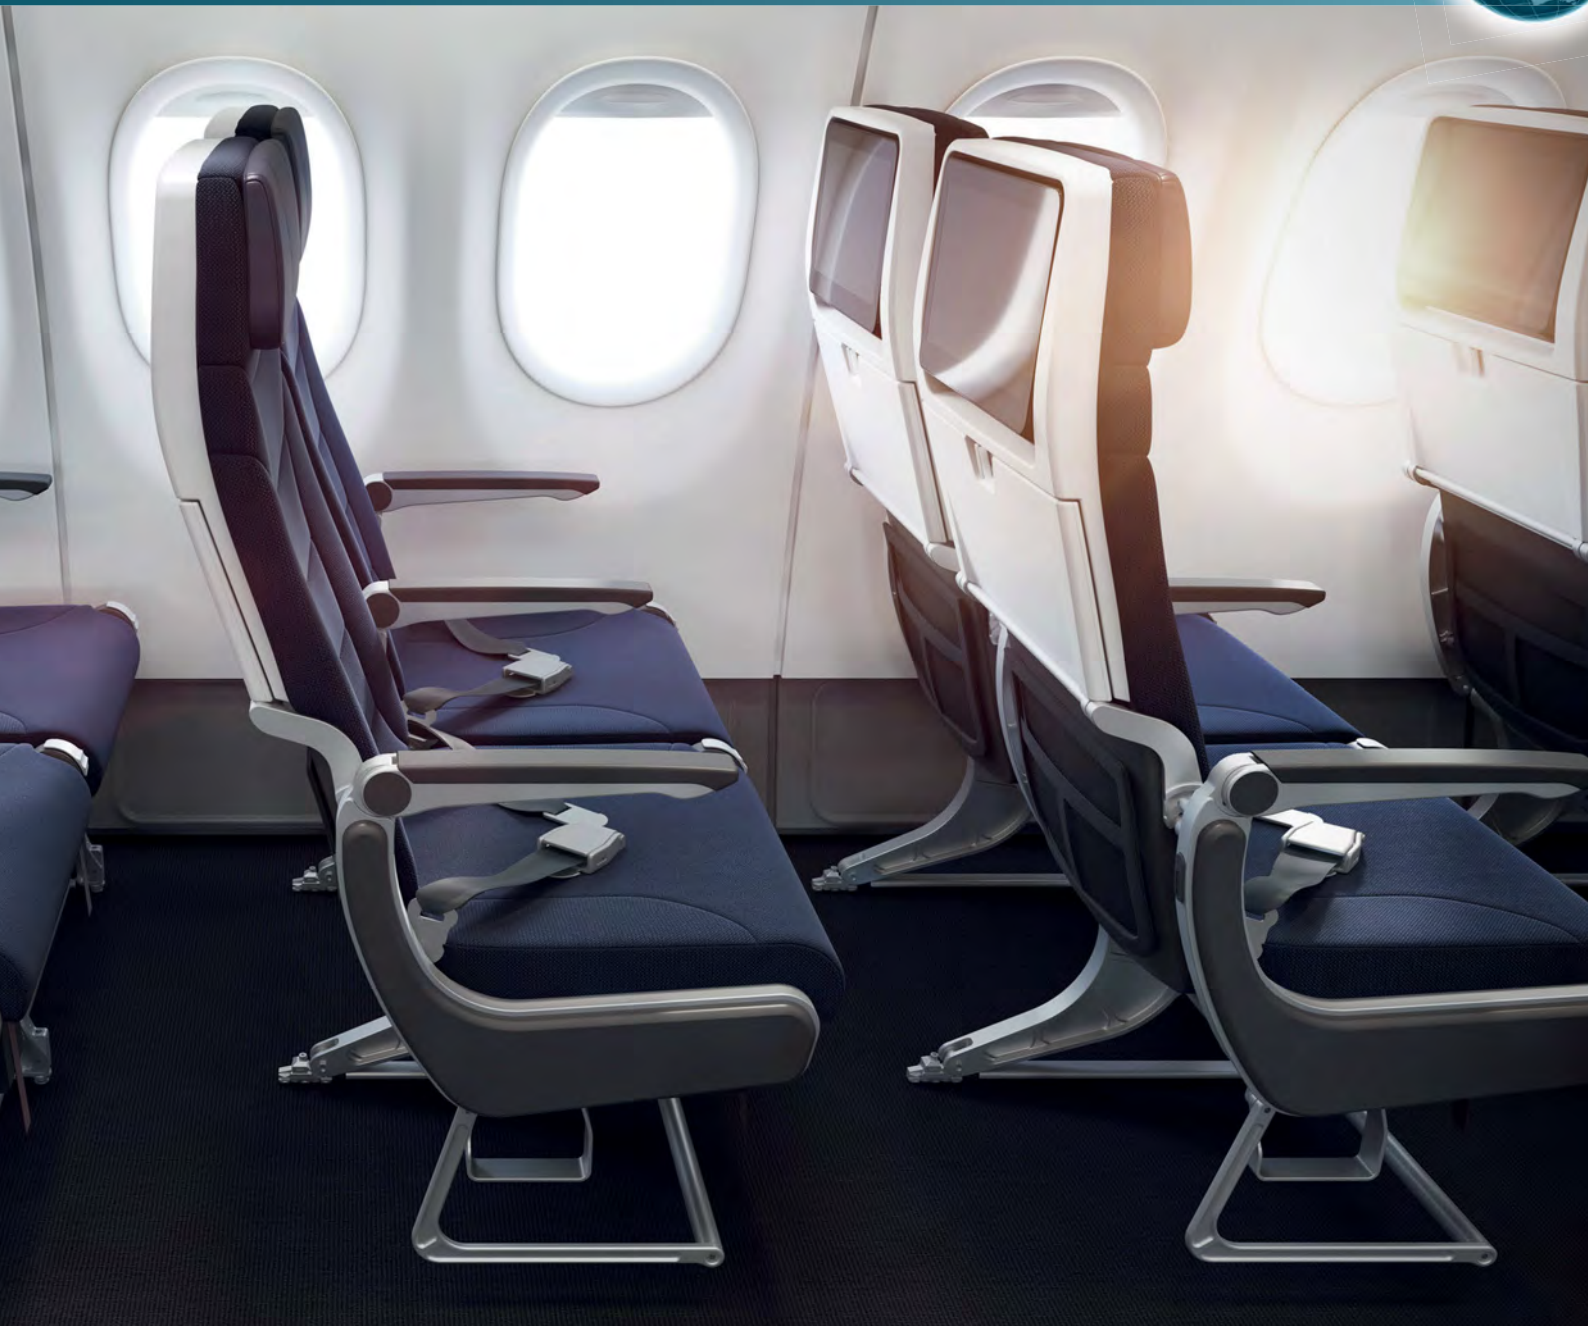
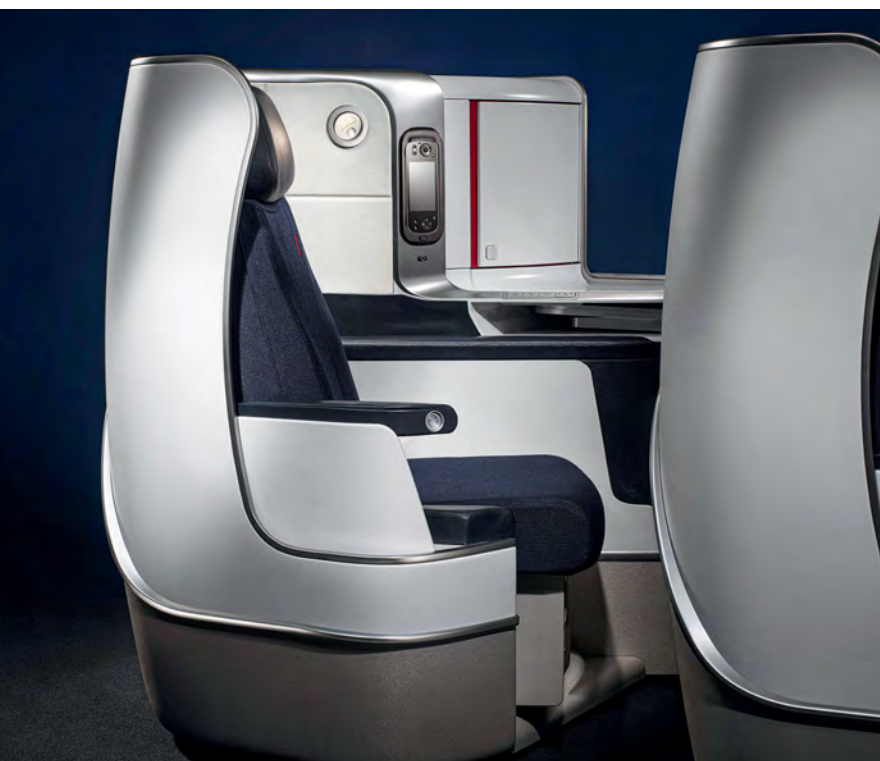
High footfall areas such as galleys and aisles need to be particularly resistant to continuous wear and tear
ACRO AIRCRAFT SEATING

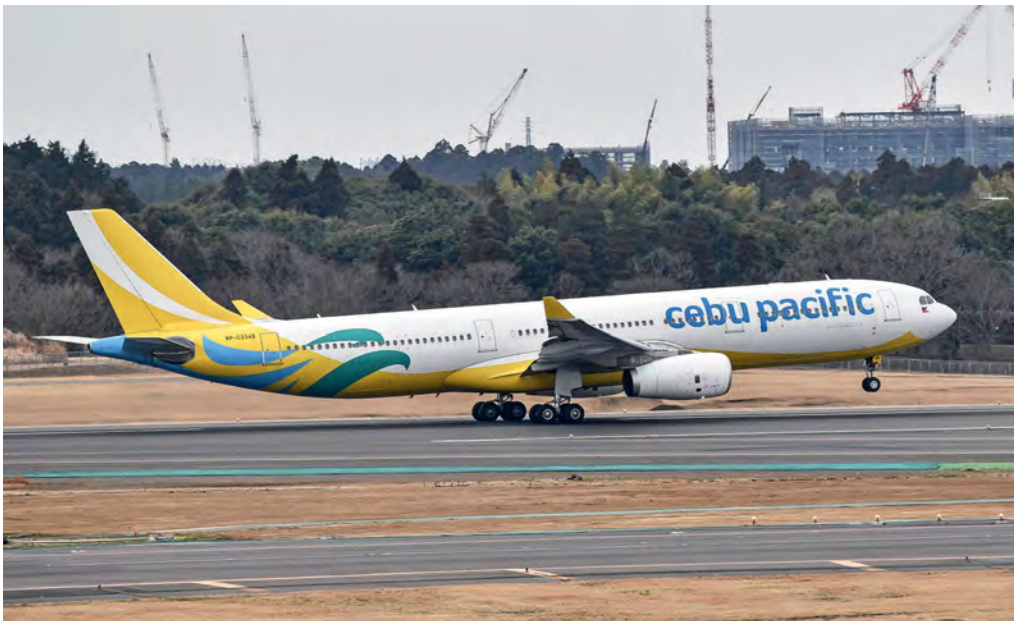
Within the MRO sector, 3D printing has been acknowledged to have kept costs down
MAGNETIC MRO

There is similar enthusiasm at MAC Aero Interiors, according to Männiste. “We are very keen on the additive manufacturing process; thus, 3D

printing is something all operators should consider as it keeps the costs and the lead time down,” he argued. “We have currently near to 50 different interior parts that can be printed, some of them make a great impact on the overall aircraft weight as using 3D printing, we can bring unit weight down by up to 40%. Currently we have worked out solutions for tray tables, bezels, arm caps, decorative panels and so on, and have plans to increase our 3D printed elements portfolio even further.”

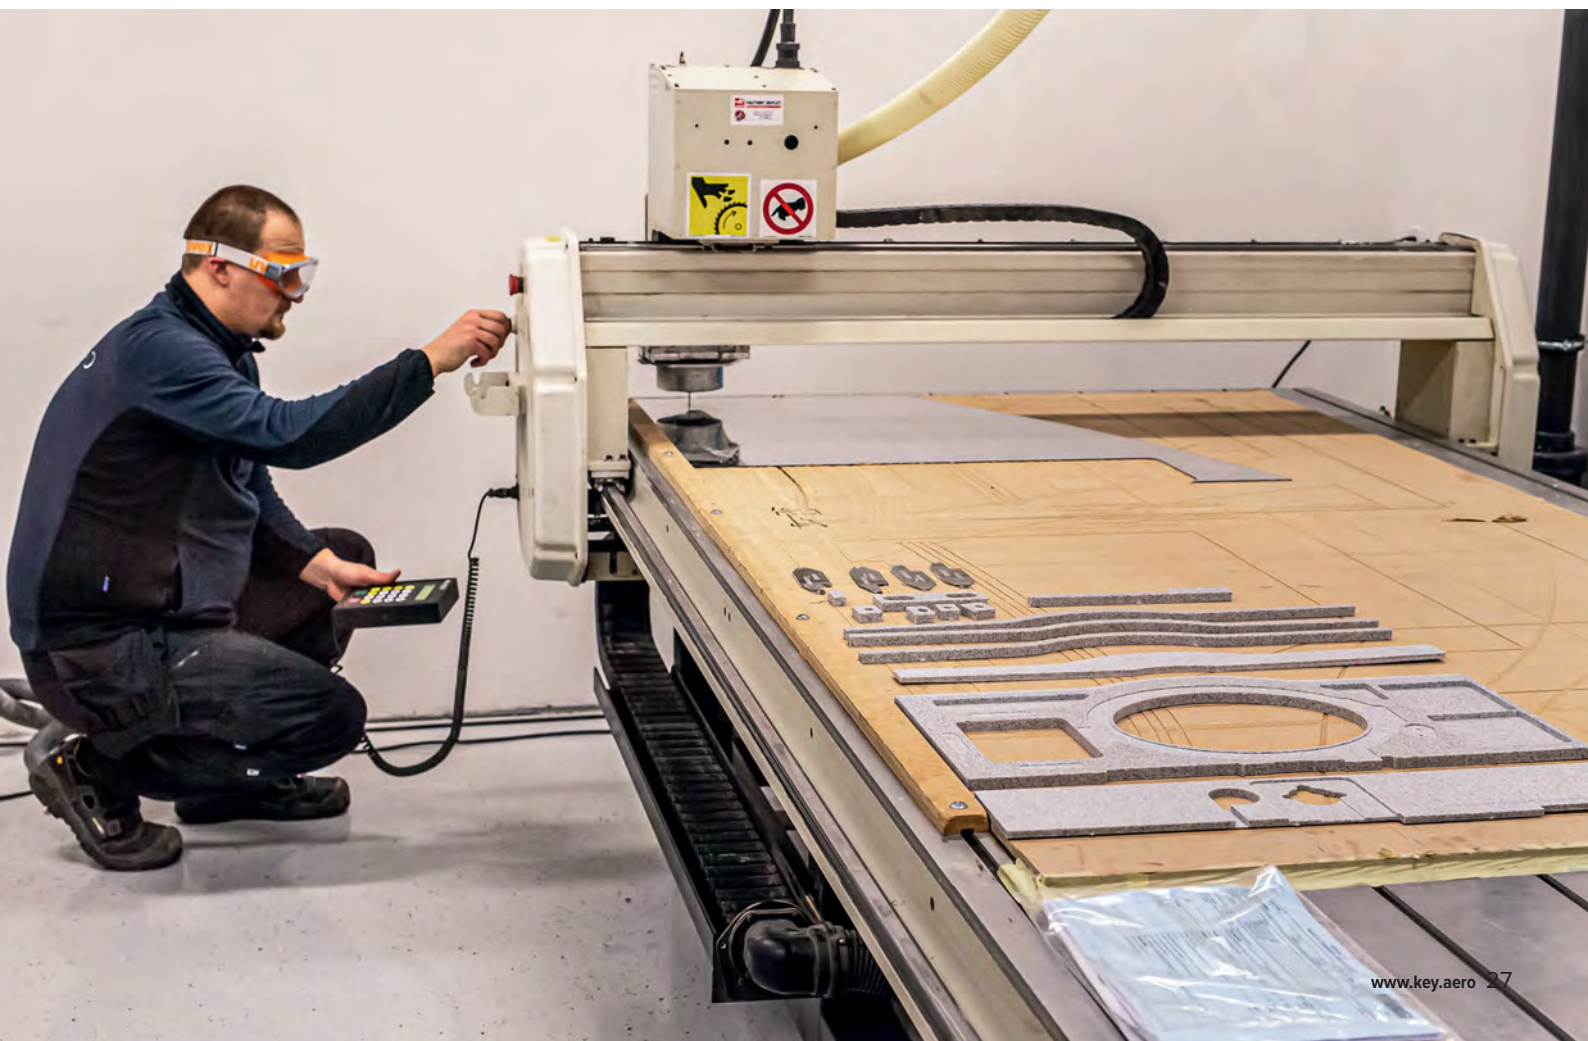
Some issues arise with the use of 3D printing. For example, many parts may not be quickly reproduced, even if a 3D printer is available, due to the intellectual property rights of the original equipment manufacturer
MAGNETIC MRO

“Even though the strength of suitable materials allows the use of 3D printed parts, the PMA process is often a bottleneck when trying to get the required drawings and load calculations in order to remanufacture a corroded part. The intellectual property rights of the OEM [original equipment manufacturer] are often the [blockage] even when 3D printing for such materials may offer a fast fix for a new part. In short, many parts could be printed at an MRO facility owning a 3D printing unit, but legal aspects and permissions to remanufacture parts often eliminate the cost-saving factor,” Schulz commented.
